'Uthmaniyah Gas Plant Completes Heat Exchanger Tube Repair

New Technique Reduces Downtime, Costs

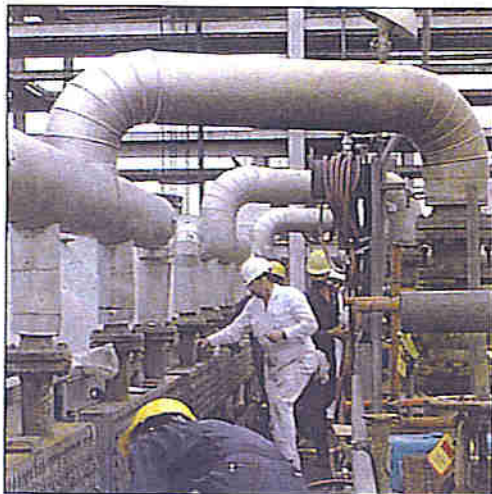
An overview of the operation in progress.

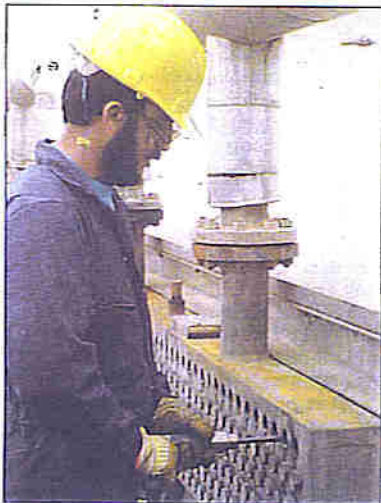
Tube ends are trimmed flush.

Before installing the inserts, the tubes were flushed with water, power-brushed clean and their ends were trimmed flush with the tube-sheet. The inserts were then driven into the tubes and hydroswaged.
