Protective shields solve condenser inlet-end erosion/corrosion problem

By Bill Stroman, Aptech Engineering Services Inc

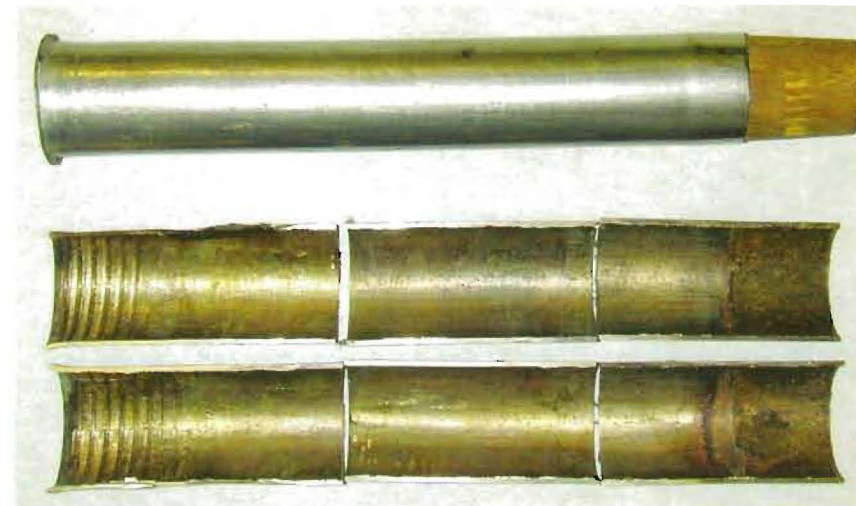
1. Condenser tube inlet where the AL6X shield had been installed is at the bottom. Note that the wooden plug could not be removed from the insert when it was extracted from the tube (top of photo)

This failure investigation offered the opportunity to review the 22-year performance history of the tube inserts. Inspection of the tube section that contained the sleeve insert confirmed that the sleeves were continuing to perform as intended (Fig 1). One of the concerns of the inspection team was the performance of the new cathodic protection system installed four years earlier. They found no evidence of erosion or corrosion at the exit end of the shield, where the potential for galvanic corrosion is highest (Fig 2).

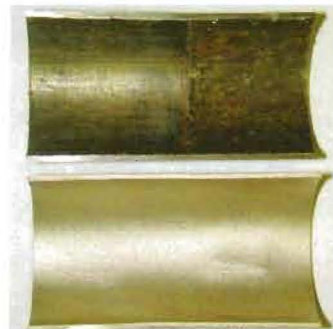
2. Tube inlet surface with shield removed shows oxide downstream of where the shield ended (top). After abrasive blast cleaning (bottom), tube shows no evidence of exit-end corrosion after 22 years
