Looking at liners

In April 2006 CTI Industries Inc. was contracted by a major oil refinery in the southwestern USA to achieve a unique full length tube lining project on two crude tower overhead (OH) fin fan condensers.

Terry Quinn, CTI Industries, USA, recounts a lining installation carried out at a southwestern US oil refinery.

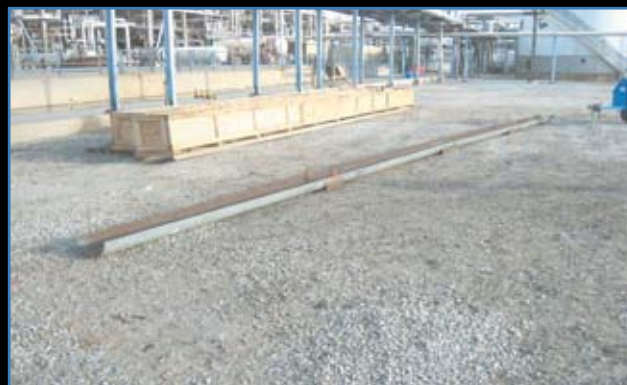
Figure 1. A 1 ft diameter pipe was cut in half. Two boxes of Hastelloy C-276 liners (in background) were loaded into the pipe and lifted by crane to 40 ft elevation for installation by CTI crew.

One potential problem following the retubing and successful hydrostatic test of the first bundle was how to support the 42 ft long liners at 40 ft elevation, which would enable the CTI crew to slide the liners through the header plug sheets and into the parent tubes before the full length hydraulic expansion process began. After discussing various options, the plant metallurgist decided to cut a 35 ft long pipe with a 1 ft diameter in half. The 42 ft liners were then loaded into the pipe and lifted by crane to the required level adjacent to the inlet catwalk and scaffolding. The liners were hand fed from the pipe, through the header sheets and tube ID's with no difficulty whatsoever. This innovation (Figure 1) was so effective that a full shift was eliminated from the original job scope for both bundles.

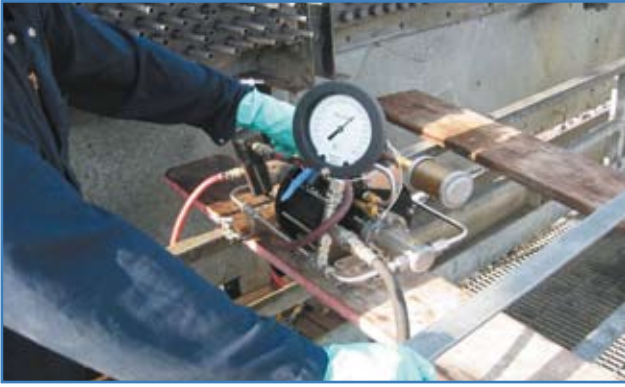
Figure 2. Portable hydraulic liner expansion pump.

a pressurised fit for the full 40 ft was placed on the inlet catwalk (Figure 2). In order to determine the pressures required to expand the liners from their original OD of 0.735 in. to a final OD of approximately 0.760 - 0.765 in., thereby creating a pressurised fit against the parent tube wall, the pump was set at a relatively low pressure of 5000 psi. Following this initial expansion, a series of ID readings were then recorded with a three ball micrometer (Elliott Tube Gauge #876200- 875). Following these readings, the pump pressure was incrementally increased until the desired ID was attained. With the final determination of 7500 psi, the pump was set and the full length expansion process began (Figure 3).

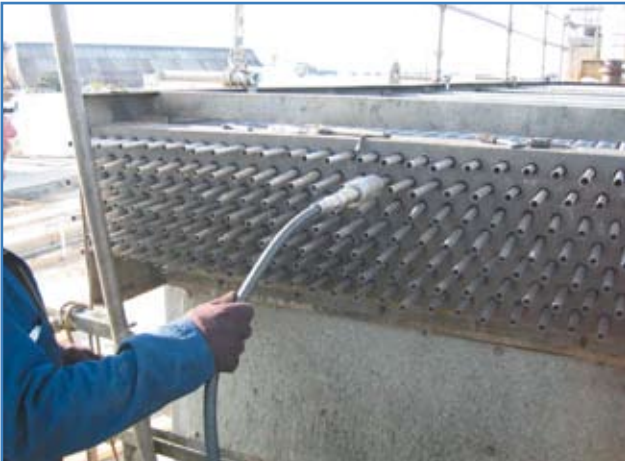
Figure 3. Inlet feed chuck for hydraulic expansion of liners to 7500 psi.

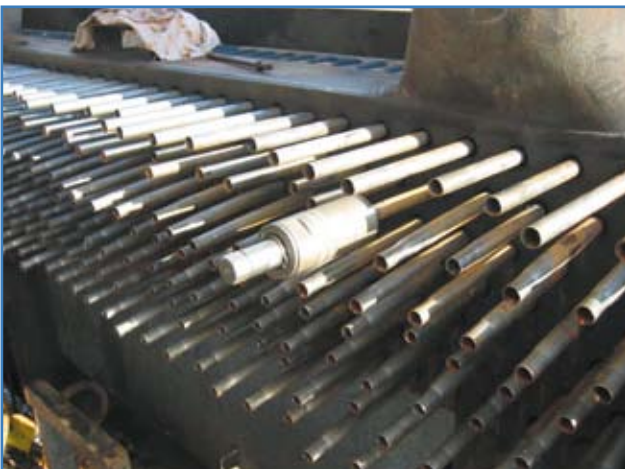
Figure 4. Outlet air bleed liner expansion chuck.

As these two pass bundles have header boxes with a 7 in. depth at the nozzle end and a 5 in. depth at the return end, an extra 2 ft of liner material was required in order for the inlet pump feed chuck and the outlet air bleed chuck to create the necessary seal on both ends of the liner (Figure 4). Once the full length expansion process is completed (Figure 5), the inlet and outlet chucks are removed and a tube ID cutter (Figure 6) set at a predetermined depth is used to sever the liner approximately 0.5 in. from the tubesheet inside the header box. With the excess liner material removed from both ends, a tube end facer is then used to remove the remaining

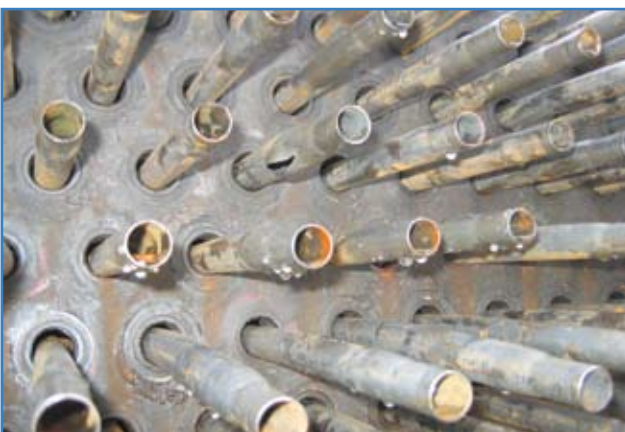
Figure 5. Post expansion of liners shown extending through header box.

A common concern and/or question by most clients at this point is whether or not the 7500 psi pressure will expand the parent tube, thereby making a future retubing either difficult or impossible. The answer is visually demonstrated in the centre section of Figure 5. As the liner wall material (0.028 in.) is substantially thinner than the parent tube wall (0.109 in.), as the pressure builds the weakest point, which is the excess liner material, will burst prior to developing pressures capable of expanding a parent tube. The resultant 'fish mouth' is illustrated here. As this does not occur until the full length expansion is completed, the process is not affected.

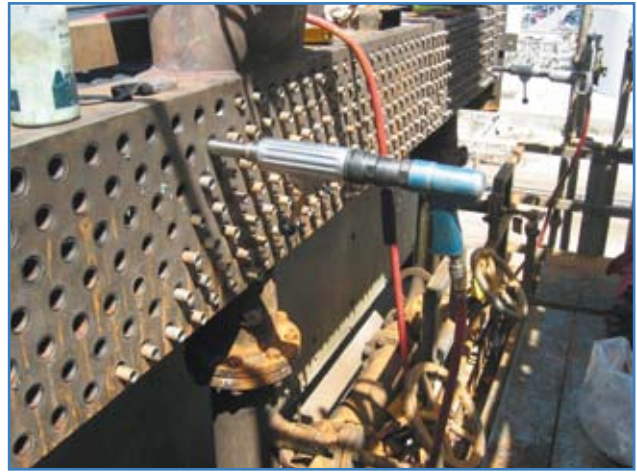
Figure 6. ID tube cutter.

0.5 in. of liner material. Upon completion of this milling process, the liners are then mechanically roller expanded at each tubesheet with a pneumatic torque controlled rolling motor to complete the expansion process. A pneumatic flaring punch sets each liner to the existing tube end and the installation process is complete. The header plugs are reinstalled and a final hydrostatic test is achieved before the bundle is returned to service.
