**I.P. FEEDWATER HEATER RESTORATION
DETROIT EDISON, ST CLAIR STATION
SEPTEMBER 2006**

**Presented for the EPRI
Feedwater Heater Technology Seminar and Conference
Memphis, TN
August 21-23, 2007**

I.P. Feedwater Heater Restoration

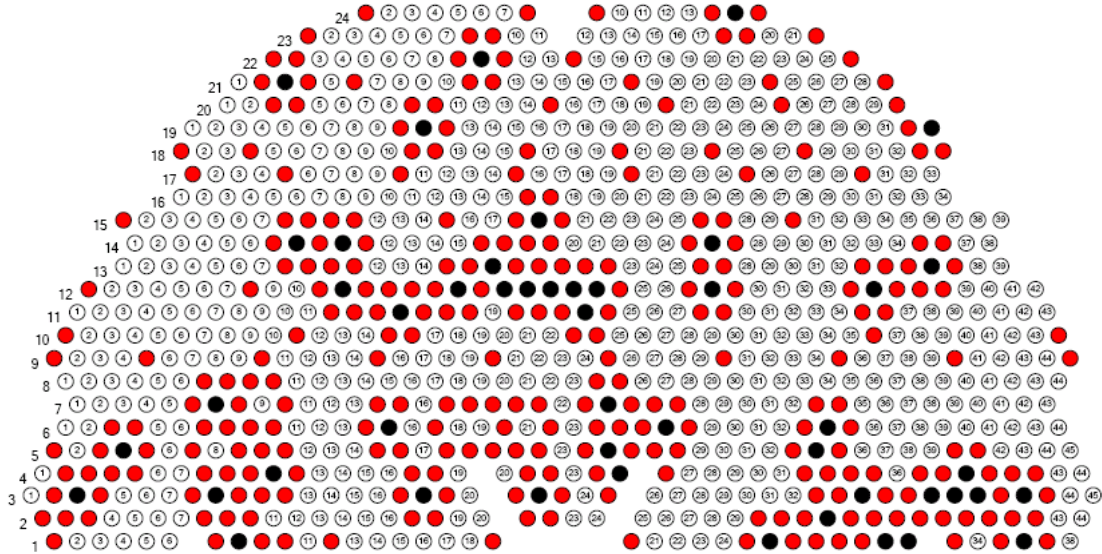
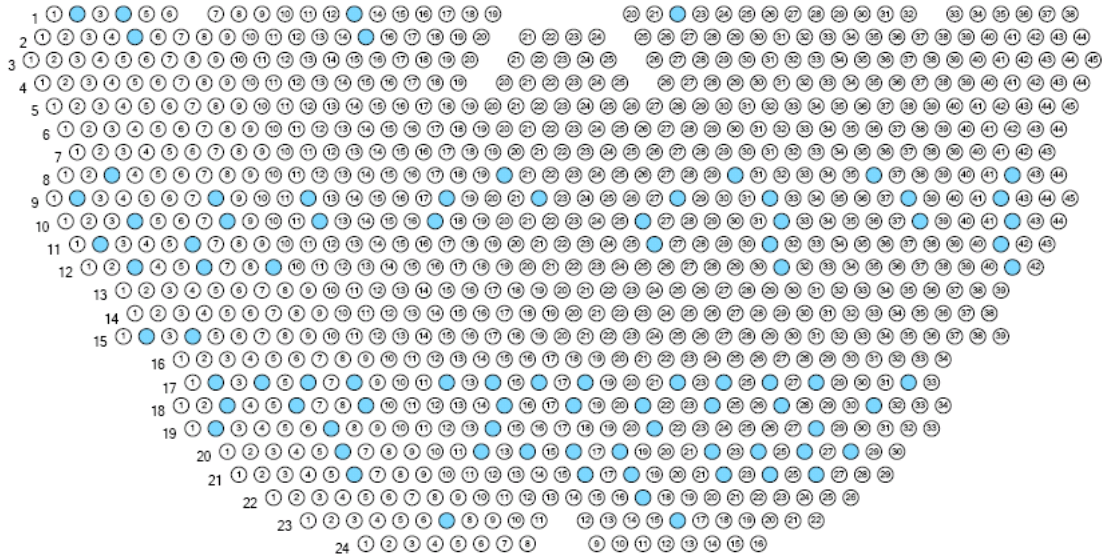
Detroit Edison St. Clair Unit 7 LP FWH 5 Results

This was confirmed as over 100 tubes were plugged within the 10 day period. Borescope pictures showed a through wall cracking that spread throughout the entire length of the desuperheating zone. Further eddy current testing was performed on 100% of the tubes, inlet and outlet tube ends. The more detailed exam revealed that all tubes at the inlet side had no sign of defect while the outlet side tube ends showed 80-100% wall loss on 278 tubes.

Character	Extent	Total	% of Total	Character	Extent	Total	% of Total	Character	Extent	Total	% of Total
② Default Tube		1377	77.01	● DENT	0	0.00		Total number of tube locations		1788	
● 20% to 39% Wall Loss	0	0.00		● NDD	85	4.75					
● 40% to 59% Wall Loss	0	0.00		● OBSTRUCTED	0	0.00					
● 60% to 79% Wall Loss	0	0.00		● PLUG	48	2.68					
● 80% to 100% Wall Loss	278	15.55		▲ RESTRICTED	0	0.00

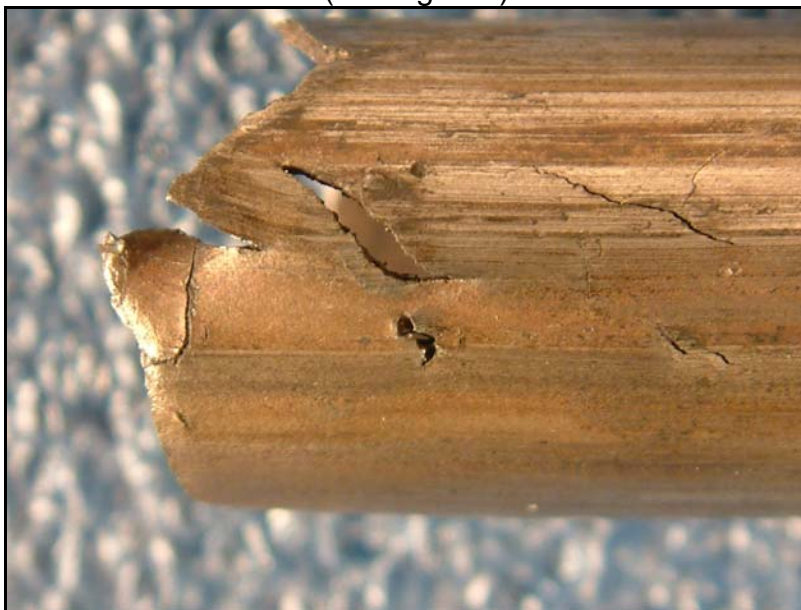
Fig.2 (up-close)

A tube sample was then removed and sent to the metallurgical lab for analysis which it revealed that the failure mechanism is due to Stress Corrosion Cracking. Additional tube testing was also completed outside of the desuperheating zone. Initial results indicated no cracking in this region. The tubes were subjected to a boiling magnesium chloride test and were found to be highly susceptible to stress corrosion cracking. Deposits of chromium, copper, and zinc oxides were also found on the OD of the tubes, particularly in the desuperheating zone.

The environmental conditions were met. The susceptible material in this case was austenitic stainless steel compounded by the fact that nickel was included. Chlorides identified during the previous start up indicate that the chloride levels were great enough even if only by excursion, to allow this mechanism to exist. High chloride levels are attributed to the large number of tube leaks on both the MU and TBFP Condensers, which are both at end of life. The dissolved oxygen levels were elevated as indicated by the surface condenser in-leakage tests.

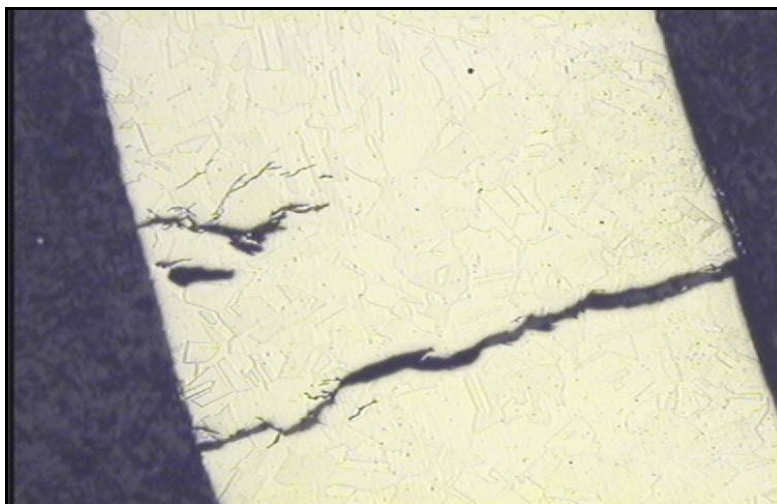
Fig 3 (50X micro)

Metallurgical testing identified the FWH #5 failure mode as OD initiated, chloride induced, transgranular stress corrosion cracking. Cracks were independent of tube support locations and welds. An eddy current examination was performed on 20 percent of the tubes. All of the tubes tested had multiple indications throughout the desuperheating zone, all of which showed wall loss of 80 percent or greater indicating failures would occur under normal operating pressures.
