## **FEEDWATER HEATER TUBE SLEEVING**

Anand Swaroop Amar, Consolidated Edison Company of New York  
Peter Tallman, CTI Industries Inc.

### **Abstract**

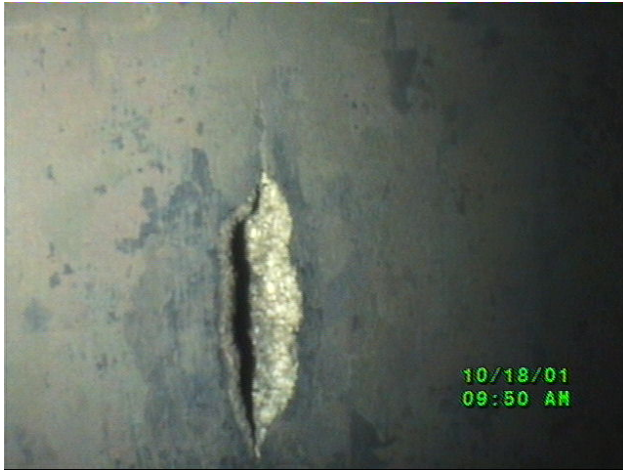
Figure 1. Leak #1 in FWH 81E

Three leaking tubes were examined. The probe (with a 90° prism) indicated that all three tubes had cracks at the same location, 4-3/8" below the top of the tubesheet. These axial cracks were short in length, but leaked through the tube wall.

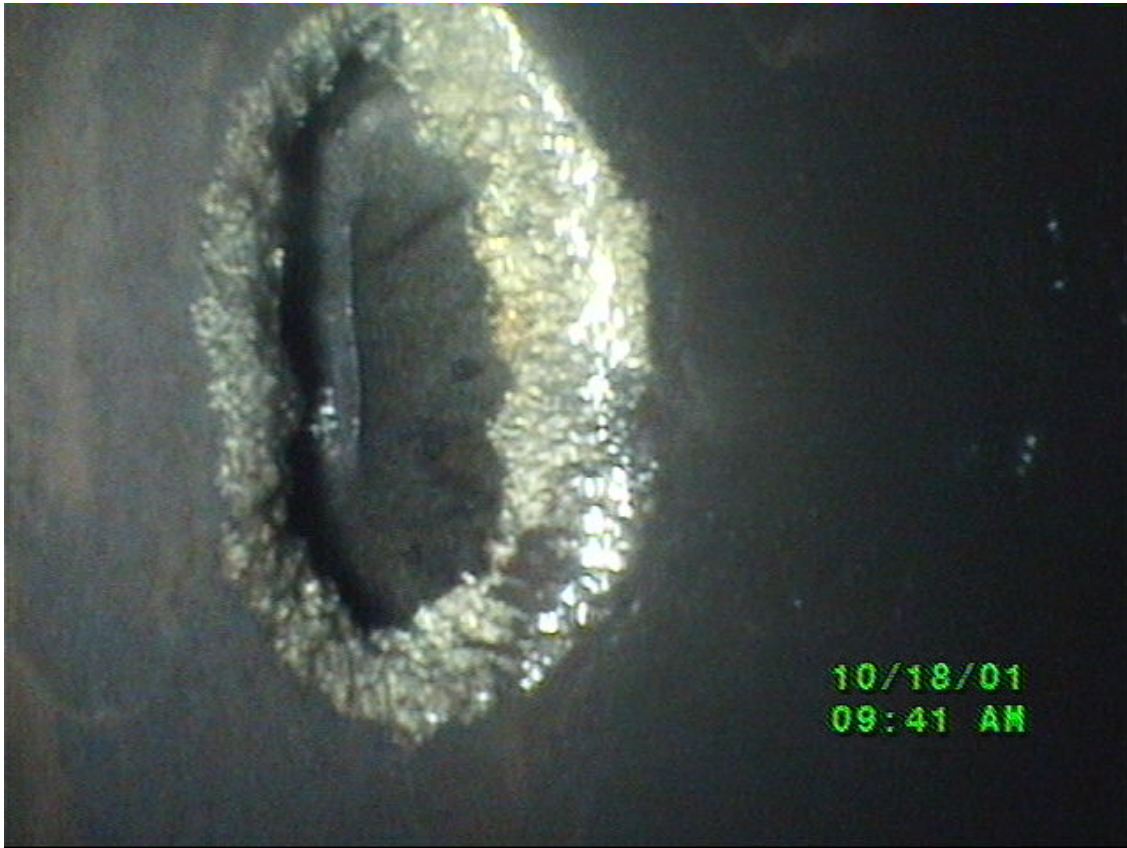
Figure 4. Leak in FWH 82W

One leaking tube was examined with the probe. This crack was also at the same location as in the Heater 81E leaking tubes; located at 4 3/8" below the top of the tubesheet. The leak started as a short, through-wall axial crack (like Figures 1, 2 and 3). However, as a consequence of erosion due to the leak, the crack became a rounded pinhole. Erosion on the tubesheet behind the tube can be seen through the hole.

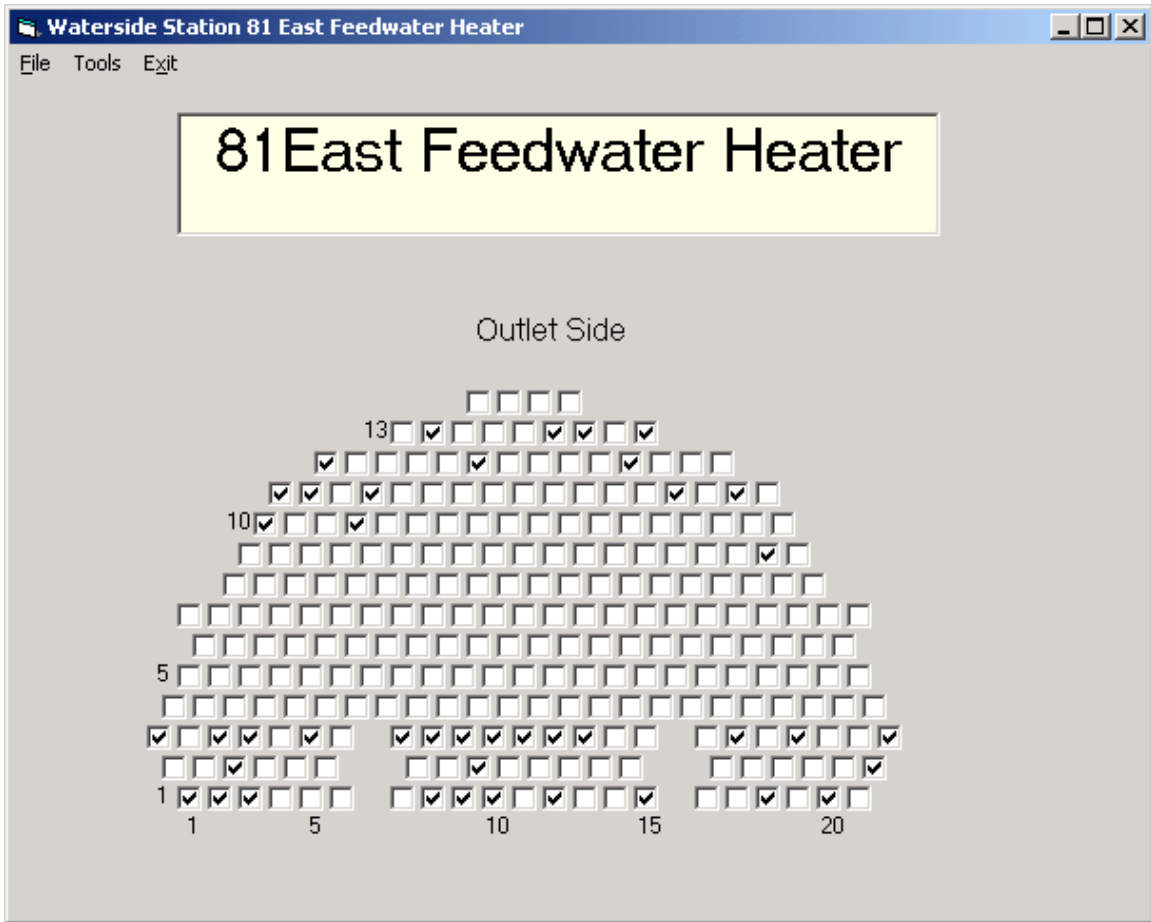
Figure 5 Tubesheet Map showing location of plugged tubes after tube sleeving.

The first three rows of #81E were preventively plugged in Spring 2003, and this heater experienced no further leaks since then. Waterside Station has a contingency plan to plug the first three rows in the other Heater, #82W if U-Bend leaks occur again. However, this heater has had no new tubes leaks since having two U-Bend leaks in Spring 2003.

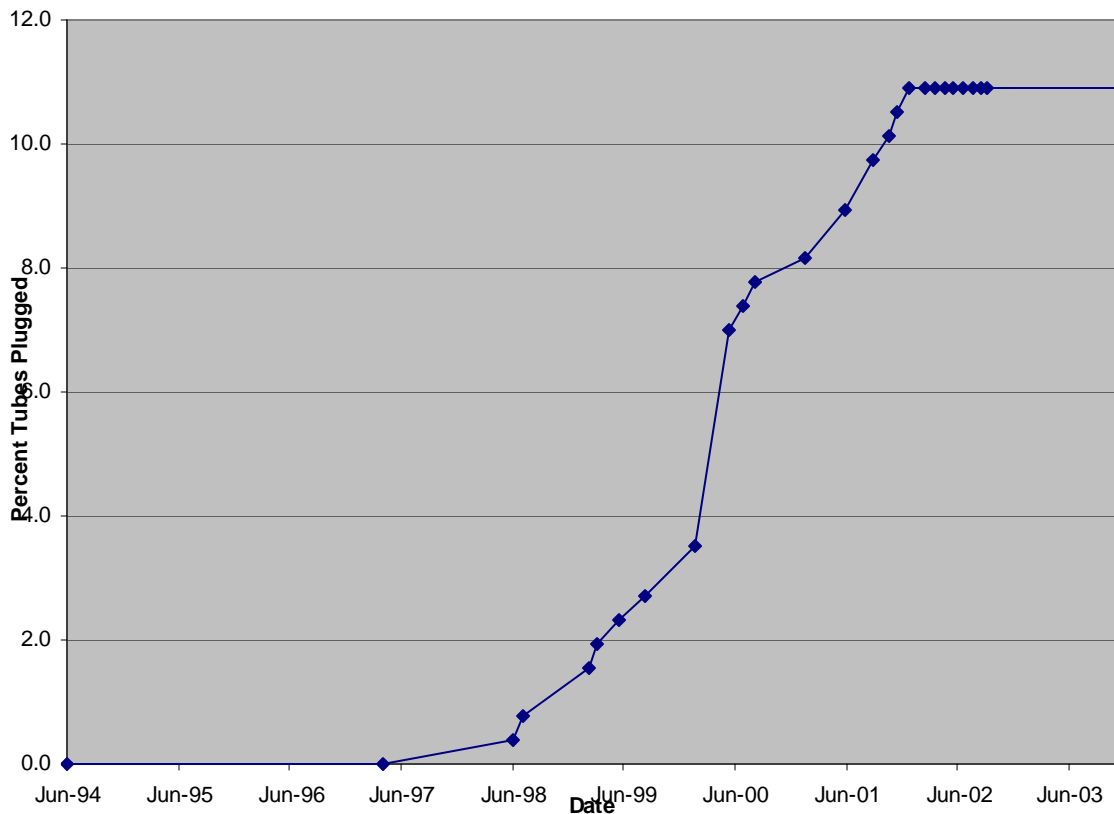
Cumulative Damage in WS 81E Heater

Waterside Heaters #81E and 82W had numerous tubes plugged after only seven years of service. Further damage to the tubes from this mechanism was accelerating rapidly (Figure 6). Considering that more than 10% of the tubes were already plugged and the Unit was experiencing too many forced outages / deratings, both of these heaters were considered candidates for replacement. This Project was undertaken to stop further tube degradation, extend the heaters’ remaining useful life, and avoid the replacement costs. Root cause analysis was performed on these two heaters using eddy current testing, remote video examination of the tube inner surface, and laboratory examination of pulled tubes. These investigations demonstrated that the tubes were leaking due to SCC in the tubesheet area.

Figure 6: Plot showing the cumulative damage in the heater. After sleeving in October 2001, further damage due to tubesheet SCC was stopped. However, there were three subsequent leaks at the U-Bends. Currently, the curve is flat (no further damage accumulation) after preventing leaks at both locations.
