Condenser Restoration
At
Exelon's Schuylkill Station
Philadelphia, PA
April, 2008

Presented for the
EPRI Condenser Technology Conference
August 12-14, 2008
St. Petersburg, FL

Kevin Shugrue
CTI Industries

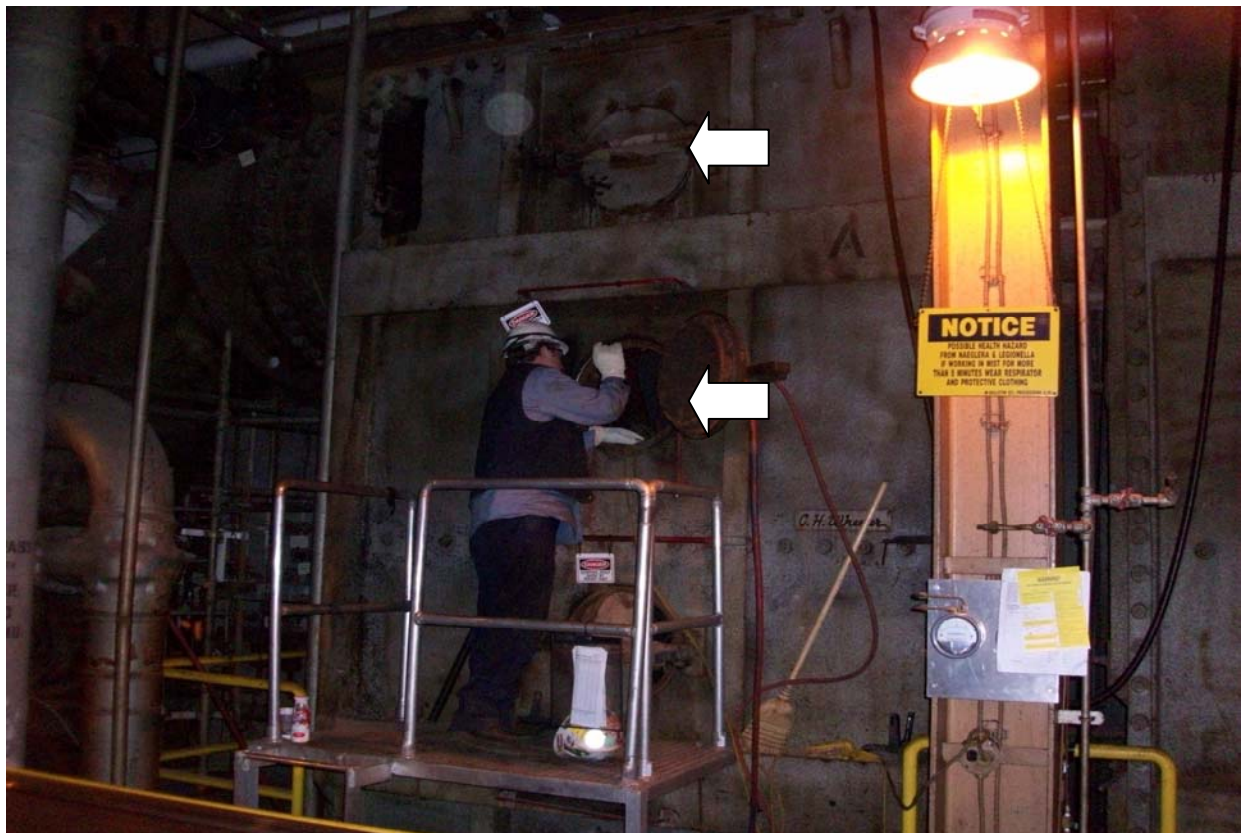
Figure 1

The condenser at the Exelon Schuylkill Station is an older vintage CH Wheeler, two pass divided water box configuration with 16,500 tubes. The 7/8' x 18 BWG Admiralty tubes were retubed roughly 28 years ago with a thinner 20BWG 90/10 CuNi in the main body and an 18BWG 304 Stainless Steel into the air removal section. The upper and lower halves of the condenser feature access doors located in the center of the unit.

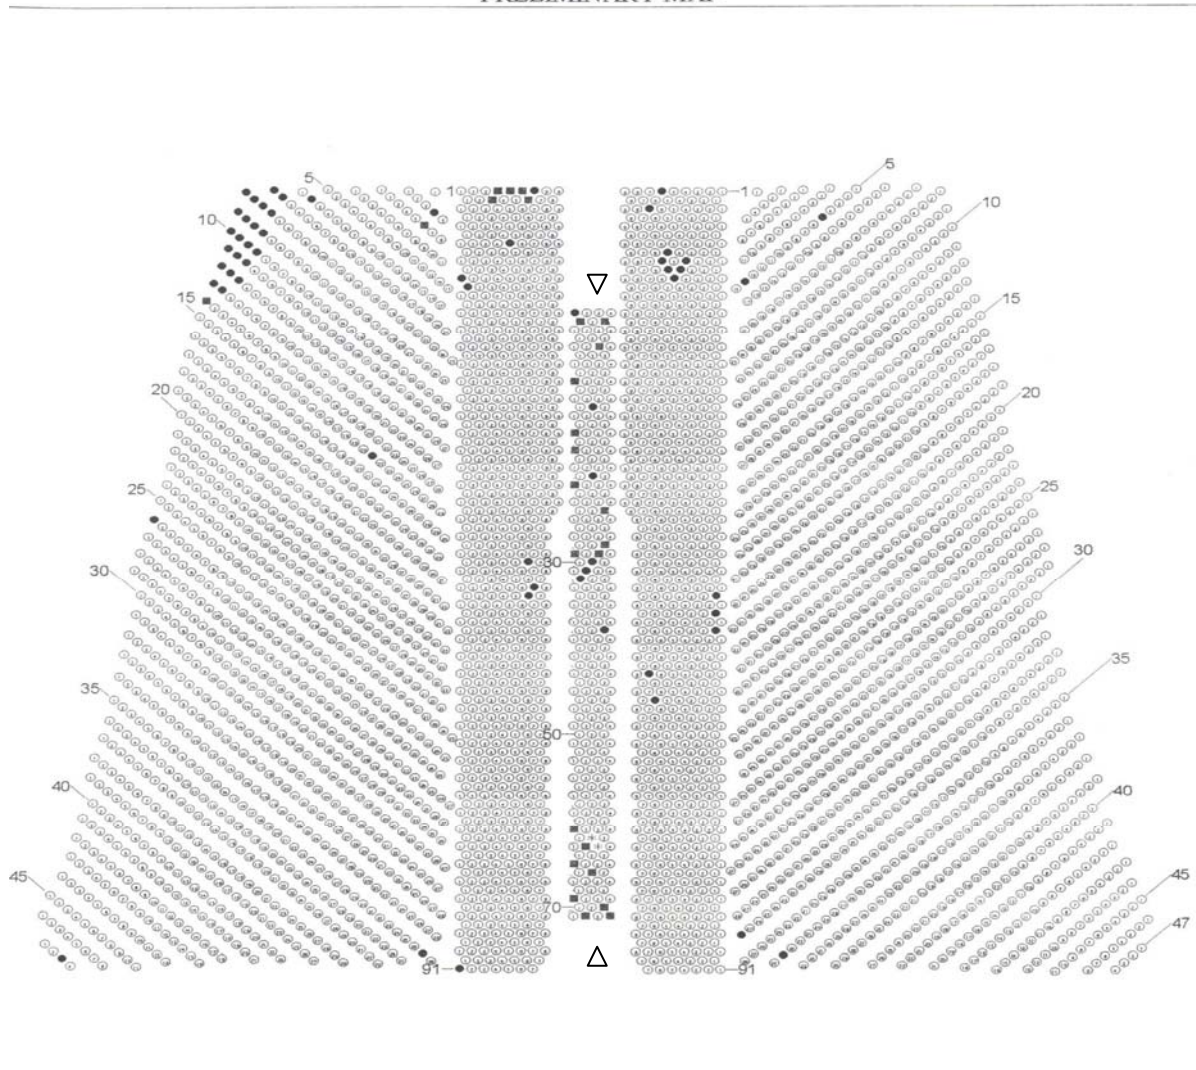
Figure 2

Schuylkill Unit 1 Tube Sheet Maps

Schuylkill Station
Main Condenser - Alpha Box
Inlet Pass (top) - View from North
PRELIMINARY MAP

The Air Removal tubes are located directly in the center of each of the upper water boxes and contain 252 tubes in each of the inlet passes for a total of 504 tubes. These 304 Stainless Steel tubes were found to have a corrosive film resembling an aggressive MIC attack which became a reliability issue of having to frequently identify leaking tubes and plug them. Other than some tubes being plugged in the upper few rows from a turbine blade problem years ago, the condenser tubes overall are in great shape and should provide years of trouble-free service.
