HIGH PRESSURE FEEDWATER HEATER REPAIR

Prepared for presentation at the
EPRI Feedwater Heater Technology Symposium

October 9-11, 2001
Birmingham, Alabama

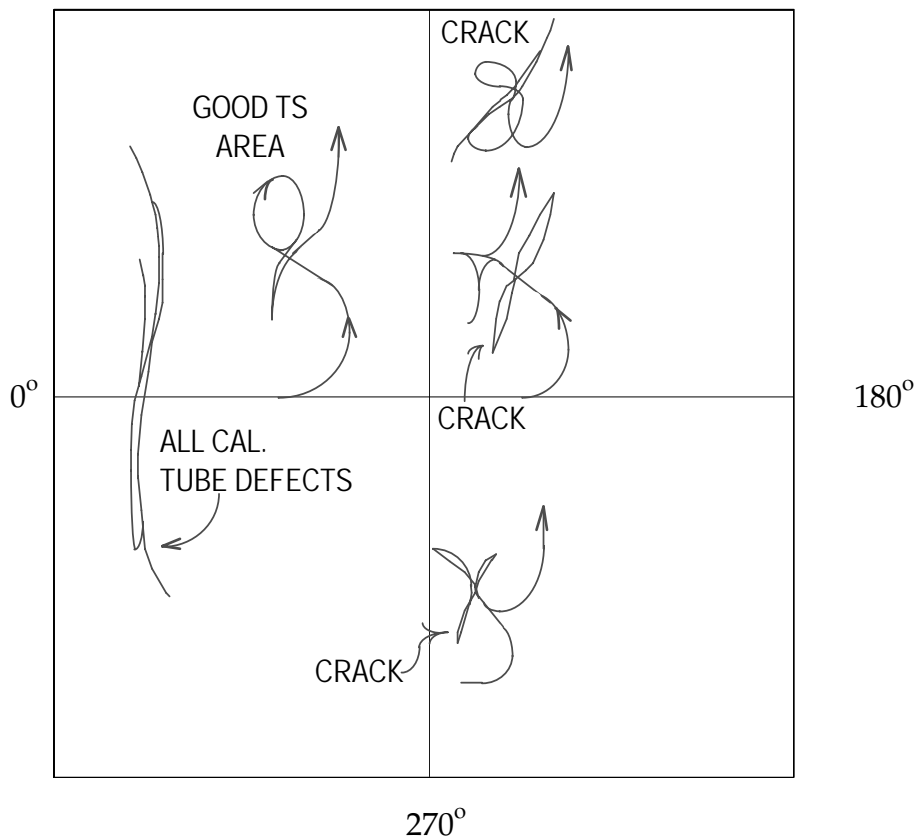
Figure 2

A special eddy current probe, designed to detect circumferential cracks and to minimize the response to conditions that are radially symmetrical, was used to inspect the tubes. Since no calibration standards were available for the conditions encountered, an eddy current pattern recognition scheme was developed based on comparisons between tubes where leaks could be observed with the borescope and others believed not to be damaged. By use of this method the leaks in all 12 failed tubes in the #5 heater and in the three unplugged failed tubes in the #6 heater were detected. Similar damage that had not progressed through wall in other tubes in both heaters was also detected using the procedure. The special probes were obtained from the EPRI NDE Center in Charlotte, North Carolina and are described briefly in figure 2.

A number of Inlet and outlet tube ends from various locations within the tube bundle were inspected in both the #5 and #6 heaters using the developed eddy current procedure. Eight percent of the nonleaking tube ends inspected in the #5 heater and five percent of those in the #6 heater exhibited eddy current signals characteristic of the damage observed in the tubes which were known to have failed. All damage detected was at precisely the same location in each tube.

The Carter C1 eddy current probe is designed to detect circumferential cracks and to minimize response to conditions that are radially symmetrical such as tubesheet presence and the change in ID at tube expansion rolls. With no calibration standards available for these conditions a pattern recondition procedure was developed by comparing signals from failed tubes where leaks were observed visually with those from other tubes where no leaks were evident. The probe was obtained from the EPRI NDE Center in Charlotte, North Carolina.

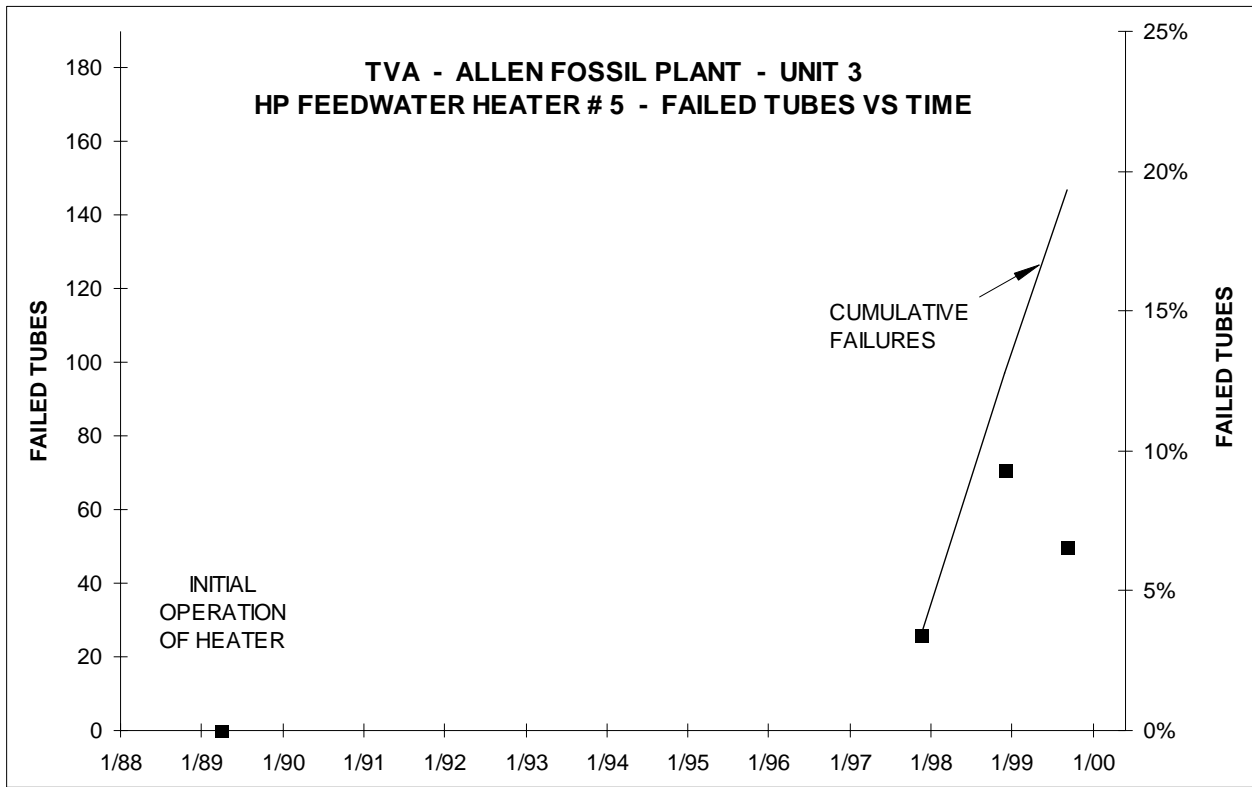
Figure 3.

As indicated in figures 3 and 4, tube failure rates in both the #5 and #6 heaters increased during the months following the initial failures. Figures 3 and 4 are tube sheet plots showing the location of failed tubes in each heater.

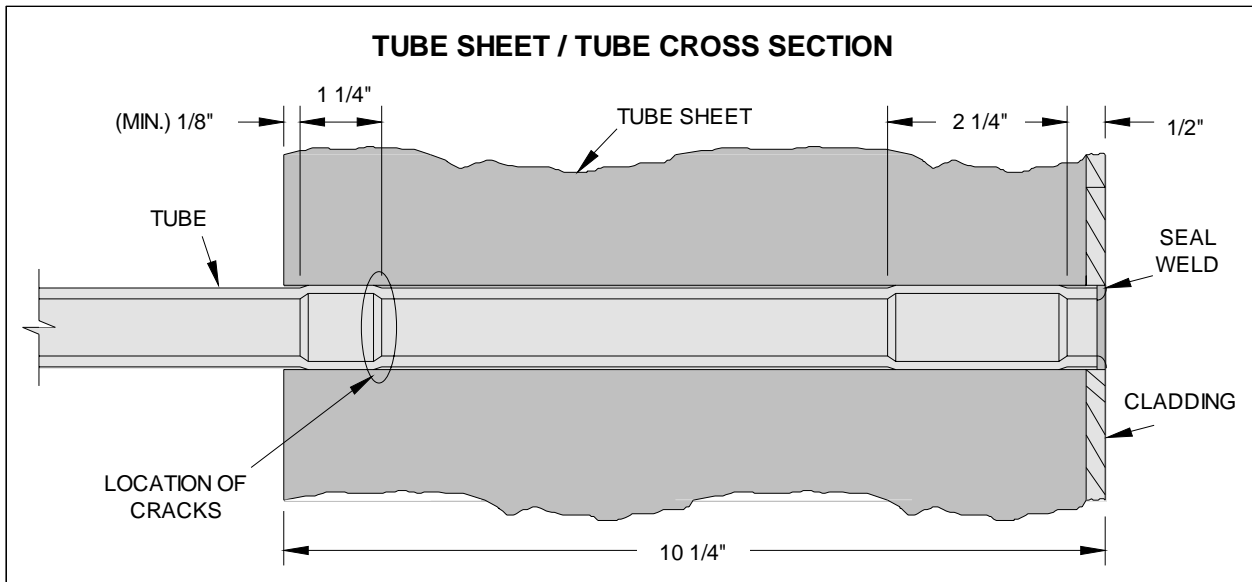
Figure 7.

All the tube damage identified in the Allen unit 3 heaters #5 and #6 was located within the tube sheet at precisely $8 \frac{7}{8}$ inches from the clad face of the tubesheet. Figure 7 is a sketch of the tube and tube sheet cross section depicting the location of failures and cracks. Microscopic examination of the retrieved failed section of tube revealed the damage to be longitudinal SCC at a tube roll transition. Borescope examinations performed after the initial discovery of the problem revealed that the failed tubes each had from one to three longitudinal cracks, all located precisely at the roll transition $8 \frac{7}{8}$ inches from the clad face of the tubesheet.

The tube rolls in these heaters are unique to those in other high pressure heaters in the TVA Fossil System. Most TVA heater tubes are step rolled inside the tubesheets with the first roll starting near the feedwater side face of the tubesheet. As depicted by figure 7, the tube ends in the Allen #5 and #6 heaters have two distinct rolled areas separated by approximately 6 inches of tubing that is not rolled. It appears that when the smaller of the two rolls in each tube end was made the tubing may have been overly stressed by the operator end of the expander rolls.

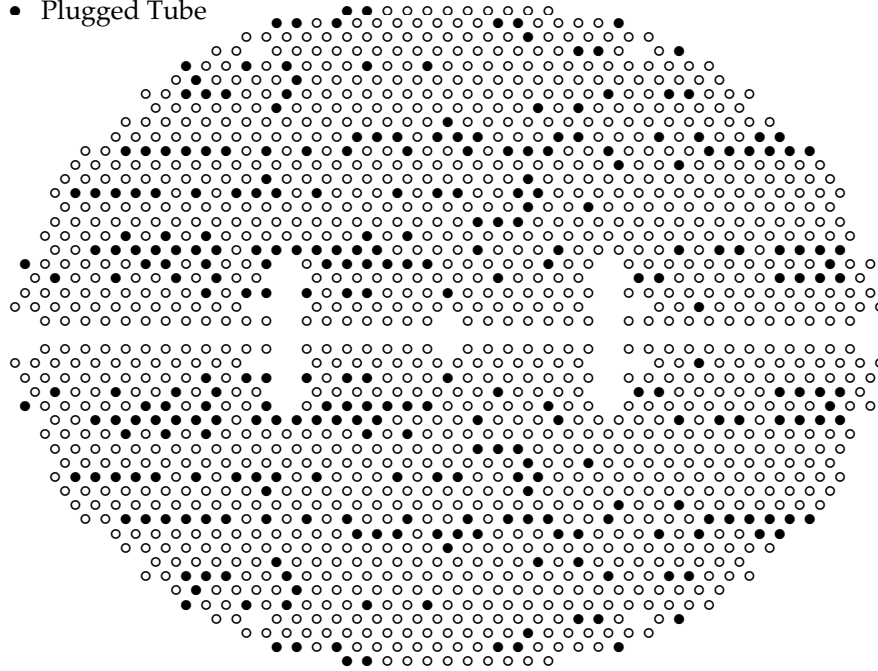
Allen Fossil Plant Unit 3 HP Feedwater Heater #5, Sept. 99
Figure 5.

- Plugged Tube

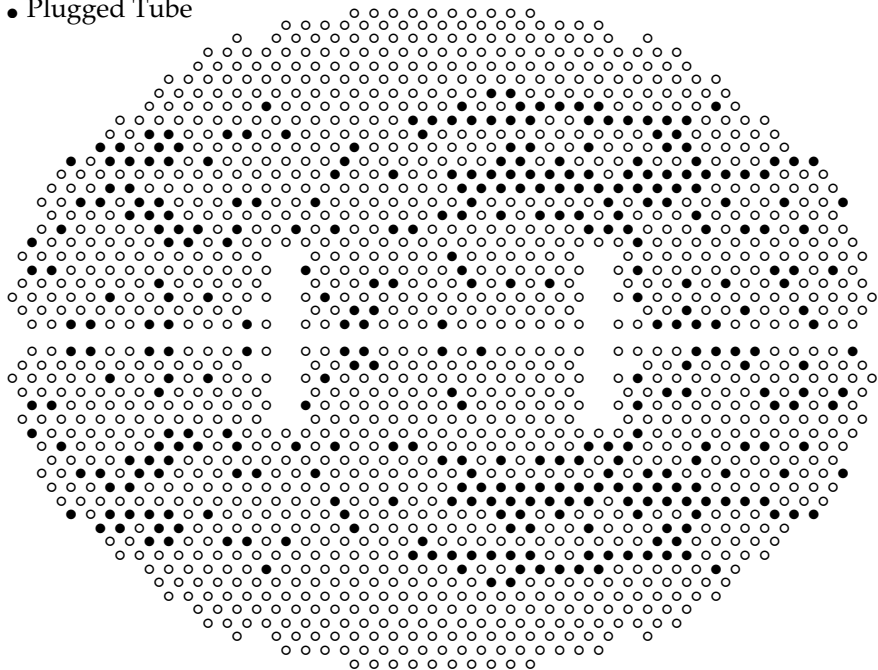
Figure 6.

- Plugged Tube

Allen Fossil Plant Unit 3 HP Feedwater Heater #6, Sept. 99
