# Protective shields solve condenser inlet-end erosion/corrosion problem

By Bill Stroman, Aptech Engineering Services Inc

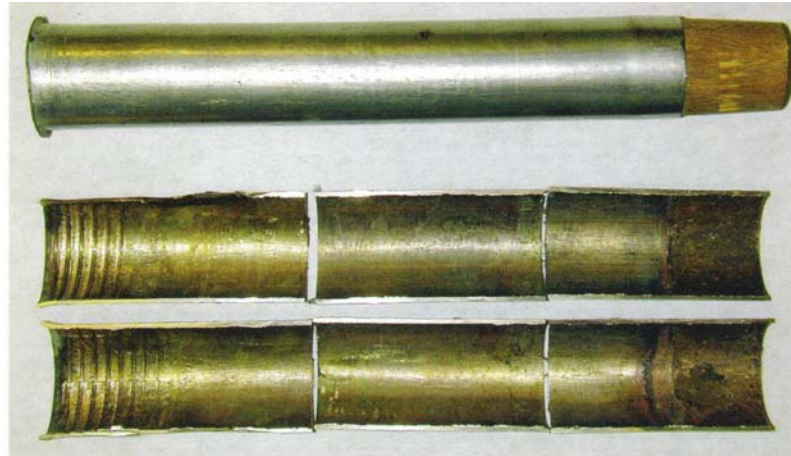
**1. Condenser tube inlet** where the AL6X shield had been installed is at the bottom. Note that the wooden plug could not be removed from the insert when it was extracted from the tube (top of photo)

This failure investigation offered the opportunity to review the 22-year performance history of the tube inserts. Inspection of the tube section that contained the sleeve insert confirmed that the sleeves were continuing to perform as intended (Fig 1). One of the concerns of the inspection team was the performance of the new cathodic protection system installed four years earlier. They found no evidence of erosion or corrosion at the exit end of the shield, where the potential for galvanic corrosion is highest (Fig 2).

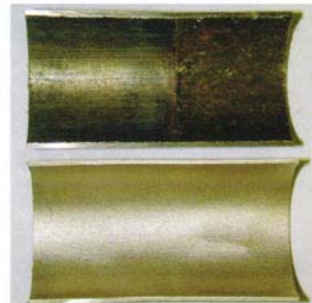
**2. Tube inlet surface** with shield removed shows oxide downstream of where the shield ended (top). After abrasive blast cleaning (bottom), tube shows no evidence of exit-end corrosion after 22 years
