Tube liners save leaking heat exchangers

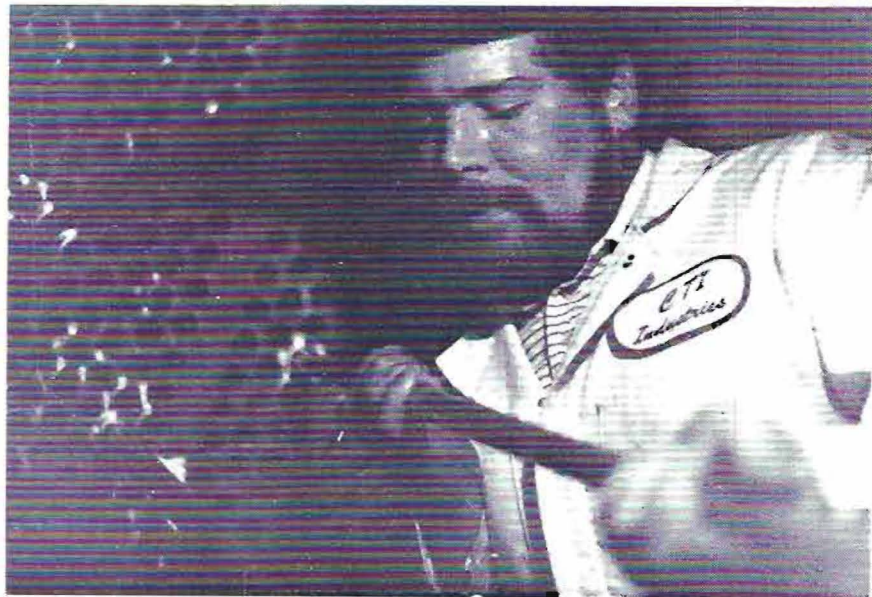
The lining process, which was developed by CTI Industries, West Haven, Conn, involves inserting a thin-walled liner into the cleaned heat-exchanger tube (see photo) and then expanding it into place by shooting a steel ball of precise size through it with a hydraulic pump.

Once in place, the end of the liner is trimmed flush with the tubesheet and roller-expanded to conform to the existing tube flare. If the liner runs the full tube length, both ends are expanded.
